COMMONWEALTH SCIENTIFIC AND INDUSTRIAL RESEARCH ORGANIZATION  
DIVISION OF APPLIED GEOMECHANICS

COASTAL EROSION, NORTHWEST PORTLAND BAY,  
VICTORIA, AUSTRALIA

TECHNICAL REPORT NO. 94

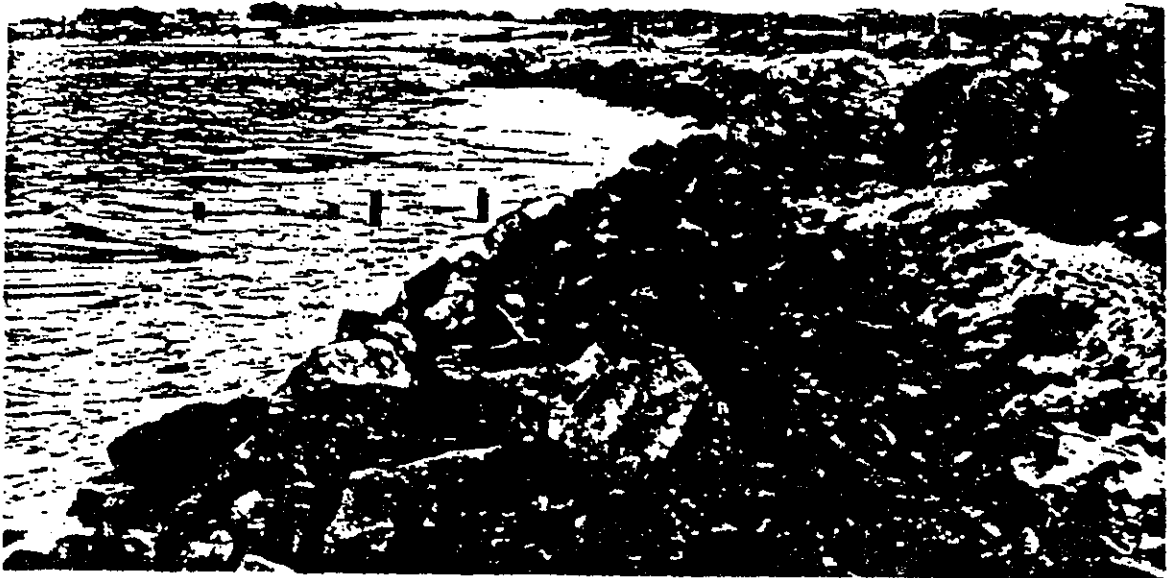
Fig. 3.- The basalt wall placed on the back beach to halt erosion. The sea removed the sand on the seaward side of the wall, admitting the waves further inshore, and so facilitating back-wall erosion. The wall was raised in 1963 and in 1979 is being further raised. Loss of a beach seaward of a seawall is the usual result. I am informed that the stumps in the photo are of an *experimental groyne*

- c.1963 Loss of the uncovered part of the beach admitted waves closer inshore, and erosion occurred through over-splash. To counter this, the height of the basalt wall was increased in 1963. However, spray erosion has continued to be a nuisance, and large amounts of seaweed are from time to time deposited behind the wall. Further raising of the wall was carried out in 1979.

Rapid erosion occurred in the first three years (between 1959 and 1962), resulting in the loss of the road along the coast, and (I am told) of three houses. I understand that the stumps seen in Fig. 3 are *on experimental* groynes. At the east end of the wall the retrogradation was measured as the distance between the landward side of the wall (since the wall was placed on the back beach zone) and the present clifflet at the back of the existing beach (Figs. 7, 8). This distance was surveyed in May 1979 and was about 62 m. From 1962 (when the wall was built) to 1979 is 17 years, which gives an average rate of erosion of 3.6 m per year. This is an exceptionally high rate. Mean erosion rates over a period of time such as this are usually measured in centimetres and not metres. That the erosion is extraordinarily rapid is shown by the fact that for most of the distance from the east end of the wall to Monaghan's house, the beach below the clifflet is lined with fallen sods with the grass still alive (Figs. 7, 8). That the sand being deposited in the eastern sector is from the shore being eroded east of the basalt wall, and virtually nowhere else, is established by the fact that no sand has accumulated on the basalt groynes jutting out from the basalt wall. The area of sand eroded is also within 2% of the sand deposited.

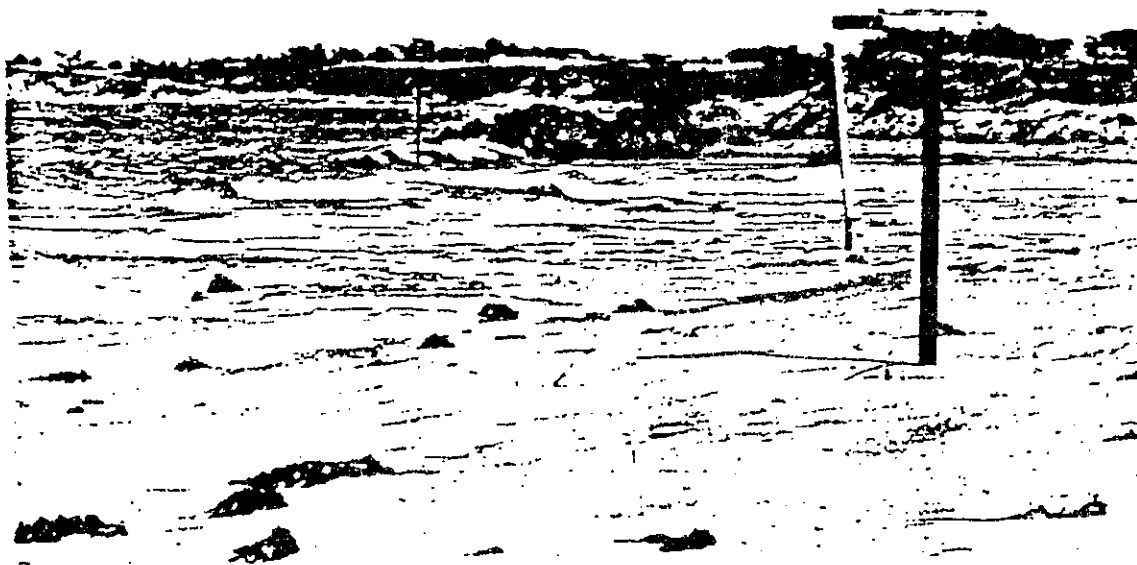
Fig. 5.- Freshwater pipes now in the sea. East end of the basalt wall  
and continued erosion in foreground.
